NOLTR 70-136

DEVELOPMENT, TEST AND EVALUATION OF  
THE ROCKET LAUNCHER SAFETY AND ARMING  
DEVICE (MLU-53/B)

1 SEPTEMBER 1970

UNITED STATES NAVAL ORDNANCE LABORATORY, WHITE OAK, MARYLAND

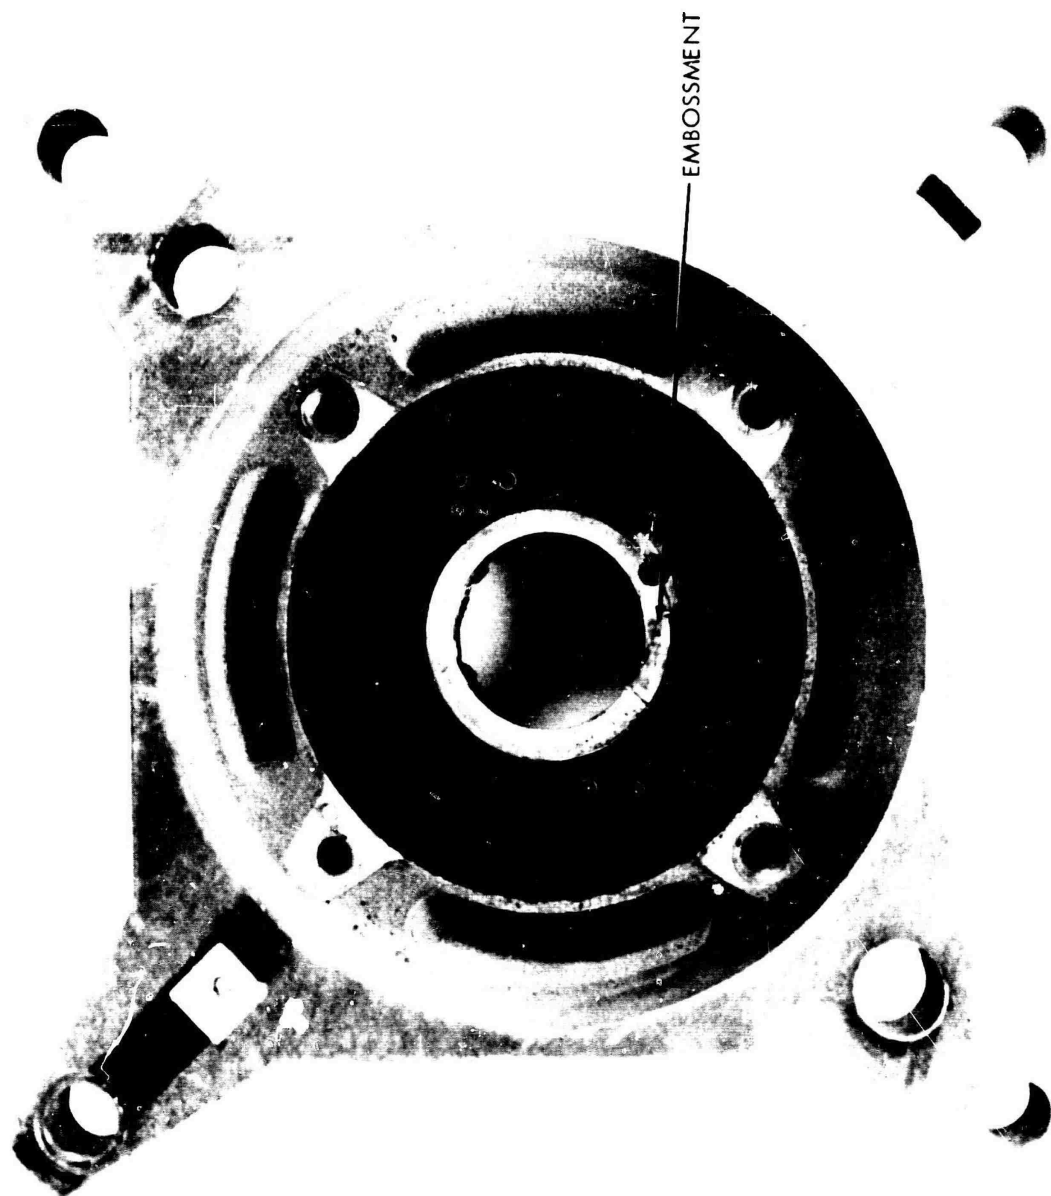
FIG. 23 VIEW OF ROTOR CAVITY SHOWING  
EMBOSSMENT OF THRUST FACE

c. Embossing of the thrust face in a cast rotor housing by a counterbore in the rotor thrust face caused rough bearing surfaces which tend to hang up (see Fig. 23).

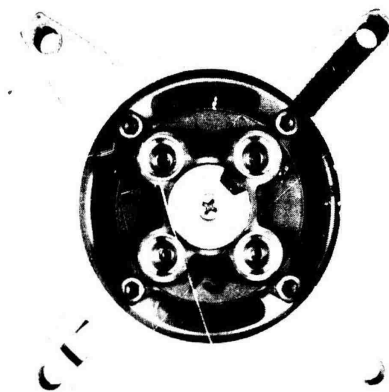
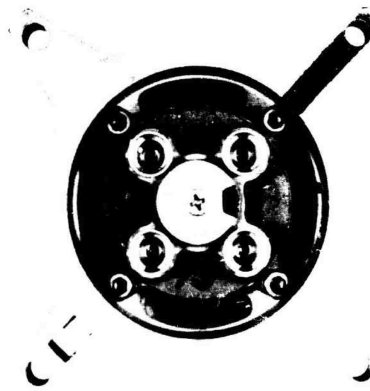
FIG. 25 S&A MODE INDICATOR

42. Figure 25 shows the S&A mode indicator. The disk rotates 45 degrees with the rotor so that the slot exposes either a red background or a green background to indicate armed or safe mode respectively. After firing a rocket, the background was found to be burned too badly to be read. The problems encountered with this indicator prompted the suggestion from NWEF, Albuquerque, New Mexico, that a safe/arm indicator be devised that could be seen from the exterior of the pod and would not be damaged by the rocket blast. However, in view of the disarm problems encountered during field tests, there was reluctance to "hanging" an indicator fix on the S&A that could decrease the available disarm-return force. It was thought that any "quick fix" would create more problems than it would solve and only a long range solution was considered practical.
